Vision Generative AI: A New Frontier for Sewage Treatment Industry

Ping Luo Associate Professor Department of Computer Science The University of Hong Kong

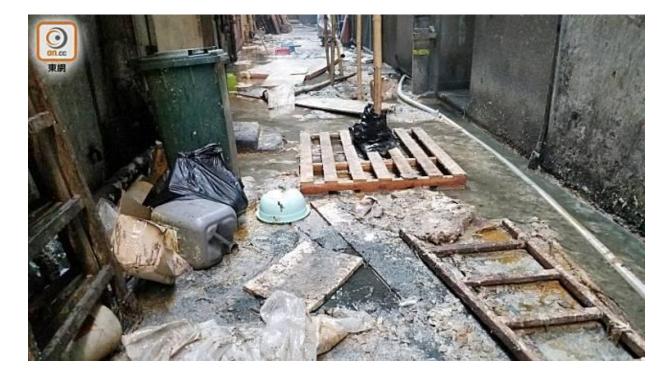
Workers at the site must exercise caution while navigating the area and ensure proper safety measures are in place to minimize the risk of accidents.

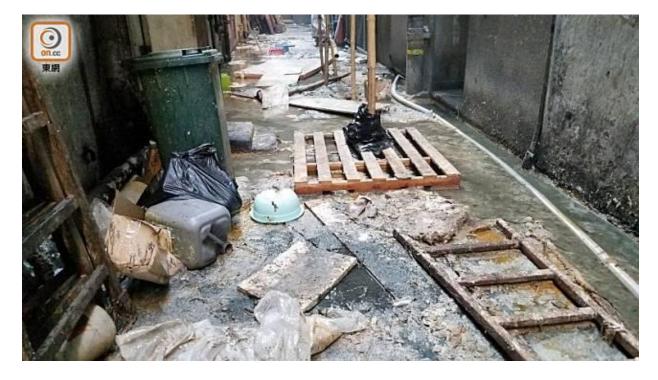
Overturned Objects: An **overturned plastic container** can be seen. Potential tripping hazard. If the container had contents, there's a risk of exposure to whatever it held.

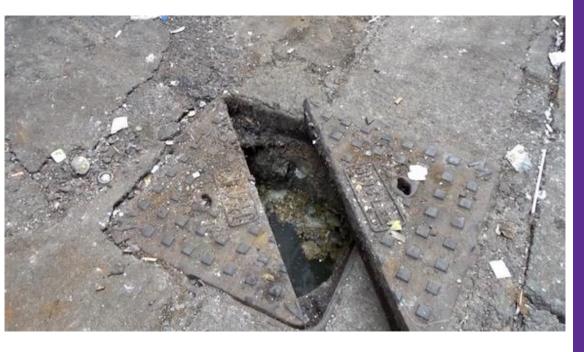
Overall, it is important to exercise caution in this area and ensure that the hole is properly fenced off and marked as a hazard to prevent accidents.

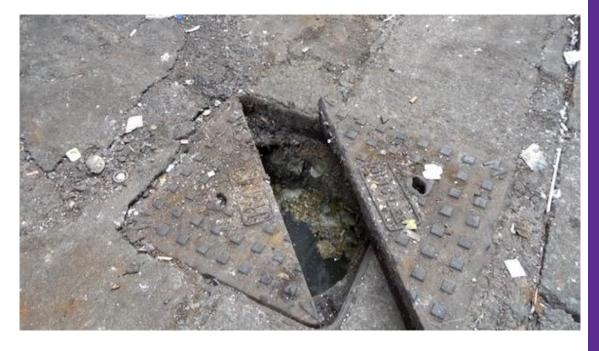
Cracked Surface: The asphalt around the manhole appears to be cracked and in poor condition.

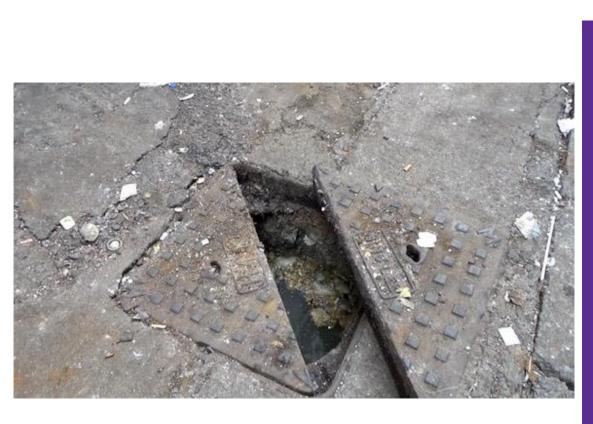
- Immediately secure the area around the broken manhole cover to prevent people and vehicles from approaching.
- Replace or correctly position the manhole cover as soon as possible.
- Clean up the debris and garbage surrounding the area.
- Assess the state of the asphalt and consider repairs or resurfacing to prevent further degradation.
- Regularly inspect such utility access points to ensure their safety and proper maintenance.

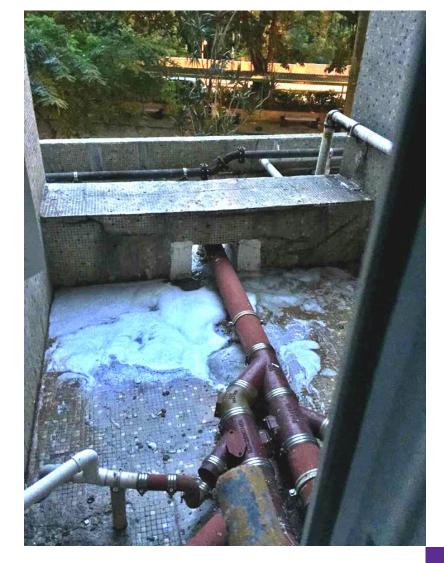
The scene appears to depict an outdoor or semi-outdoor area, possibly a service or utility section of a building or structure, with visible plumbing and piping systems. Here are the elements observed and the associated potential safety hazards:

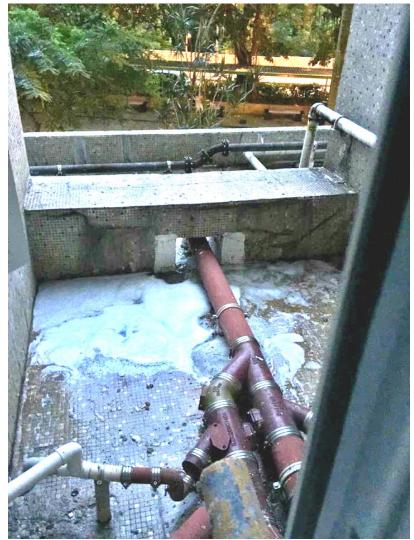
- Regularly inspect the piping system for any signs of wear, tear, or potential leaks.
- Clean up the foamy substance and investigate its source to prevent future occurrences.
- Regularly clear debris from the area to maintain a safe walking surface.
- Consider repairs or renovations for uneven or damaged flooring.
- If the exposed brickwork is a sign of unfinished construction, ensure it's completed or properly secured.
- Regular pruning or maintenance of the vegetation can reduce the risk of falling debris.

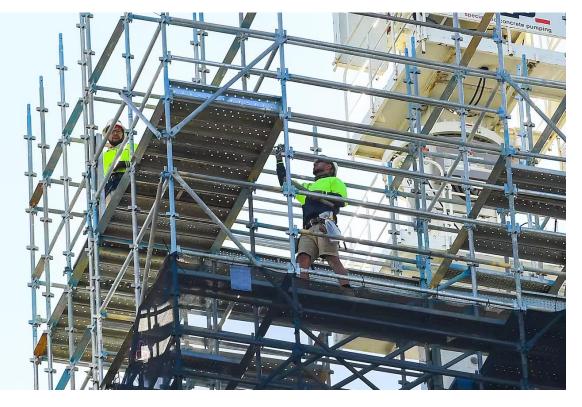
Additionally, proper training and supervision of the workers should be provided to ensure they are aware of the potential hazards and can work safely on the site.

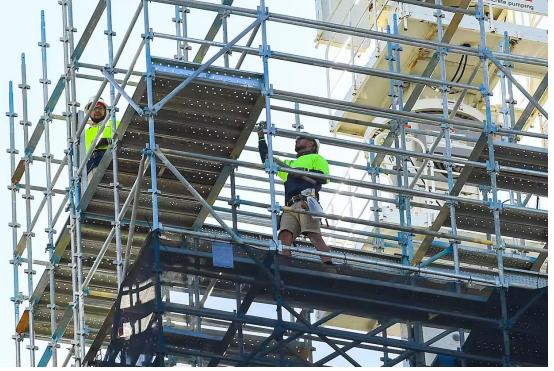
Overloading: Adding too much weight on the scaffolding, either by workers or equipment, can cause it to become unstable.

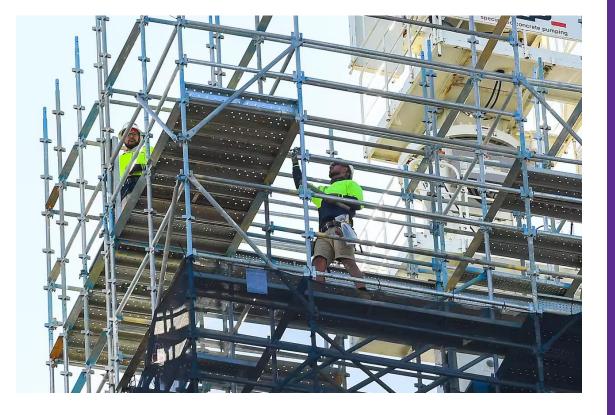
- Ensure the scaffolding is erected, modified, and dismantled by competent individuals and according to manufacturer's guidelines.
- Regularly inspect the scaffolding for structural integrity and stability.
- Ensure all workers are trained in the safe use of scaffolding and are aware of potential hazards.
- Ensure that workers wear appropriate personal protective equipment (PPE) and that it's in good condition.
- Regularly inspect harnesses and other fall protection equipment for signs of wear and tear.
- Establish and enforce a tool tethering policy to prevent tools and equipment from falling.
- Limit the number of workers and the amount of equipment/material on the scaffolding to avoid overloading.

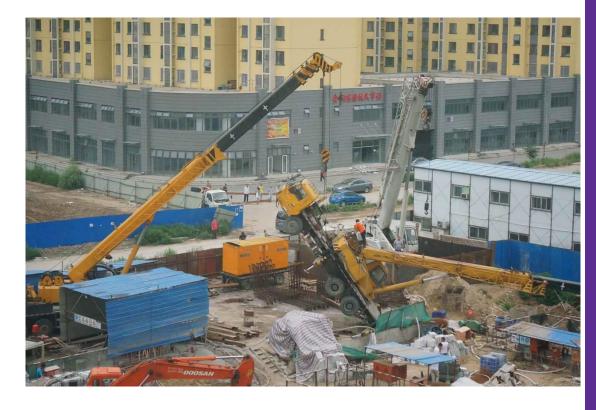
Pedestrians: There appear to be non-construction personnel or pedestrians on the road adjacent to the construction site. External Risk: They might be at risk from any unforeseen accidents or debris coming from the construction site.
